Benthic TMDL for Quail Run, Rockingham County, Virginia

Virginia Department of Environmental Quality

Department of Biological Systems Engineering, Virginia Tech

February 6, 2003

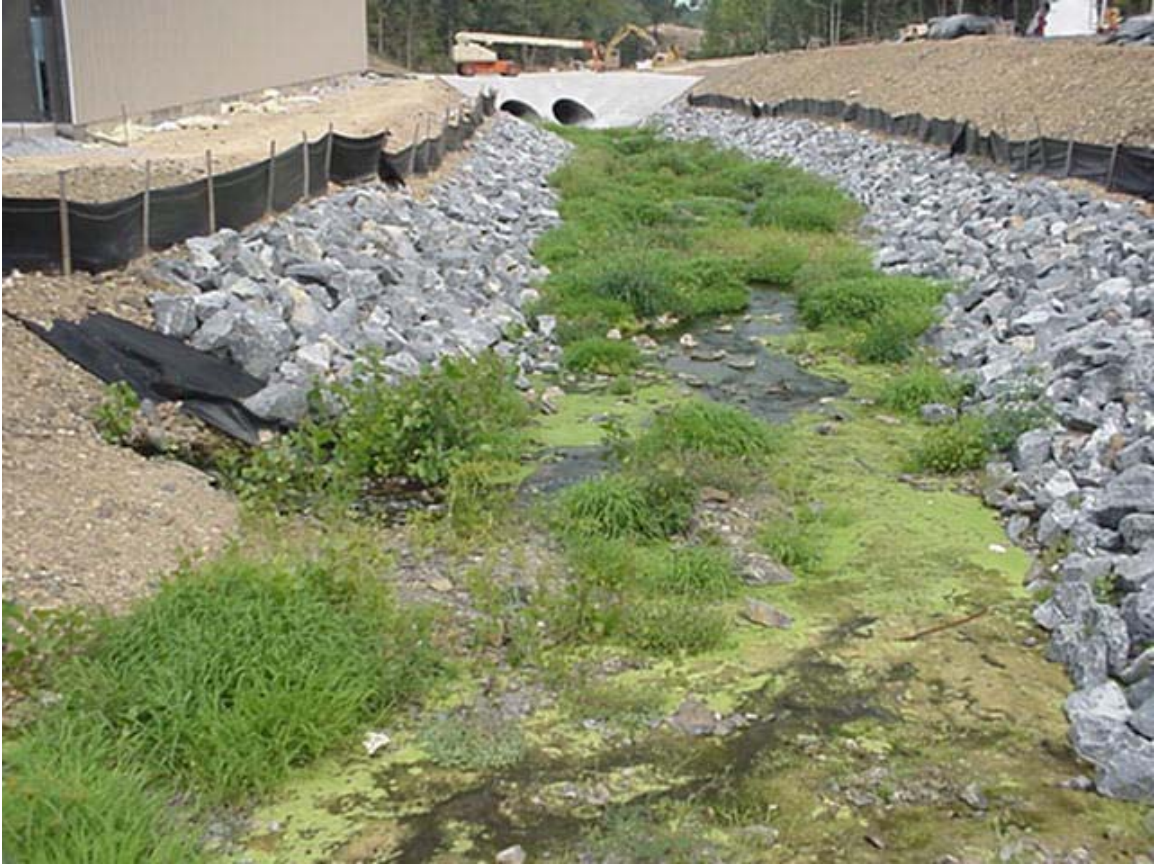
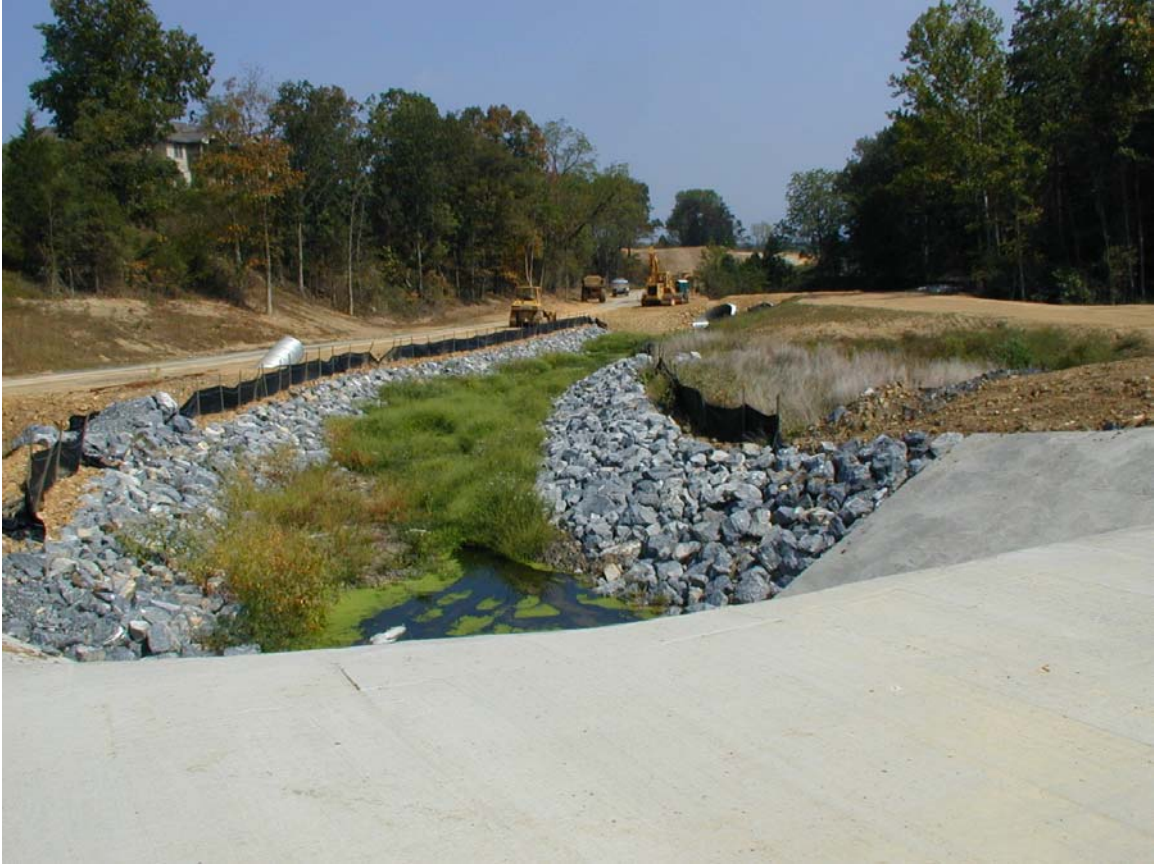
Due to the construction of the new STP and the recent expansion of the Massanutten development and golf course in the area downstream of the existing STP, several thousand feet of formerly meandering and forested riparian zone were, or are, in the process of being cleared. In the immediate vicinity of the STP, the existing stream was straightened and stabilized in places with riprap for approximately 350 ft downstream of the STP outfall as shown in Figures 4-15 and 4-16. Elimination of the forest canopy greatly increased the amount of sunlight reaching the stream channel and is believed to have caused/contributed to the observed increased growth of periphyton (attached algae) in the stream downstream of the STP. Prior to the clearing of the riparian zone and the elimination of the forest canopy, eutrophic periphyton growth was not reported to be a problem.

Figure 4-15. Channel modifications in the riparian zone due to STP construction.

Figure 4-16. Channel modifications downstream of STP.

It is recommended that a forested riparian canopy be reestablished in the disturbed riparian zone downstream of the STP to increase stream shading during the late spring to fall period and avert nutrient related periphyton growth problems. The Massanutten development is currently investigating costs associated with reestablishing the riparian canopy and is expected to enter into an agreement with VADEQ to partially restore the riparian canopy downstream of the STP.

In the last two years 350 ft. of the stream inspected had been channelized, denuded, and the stream bank tree's were removed as part of the STP replacement. Because of this the stream bottom gets many times the illumination it was getting formerly, and stream bottom algal growth, particularly below the discharge, has increased dramatically. Because of this large algal biomass standing crop, I believe the night time DO values have dropped dramatically (to ~1 mg/l DO for much of the night). So the DO values speaks to stream shade removal and nutrients, and not to BOD."
